GEOTECHNICAL ASSESSMENT

**Proposed Development
Part Lot 6, Concession 14
Geographic Township of Aldborough
Community of Port Glasgow
Municipality of West Elgin, Ontario**

Report Number: 07-1130-188-0-R01

April 5, 2016
Revised May 17, 2016

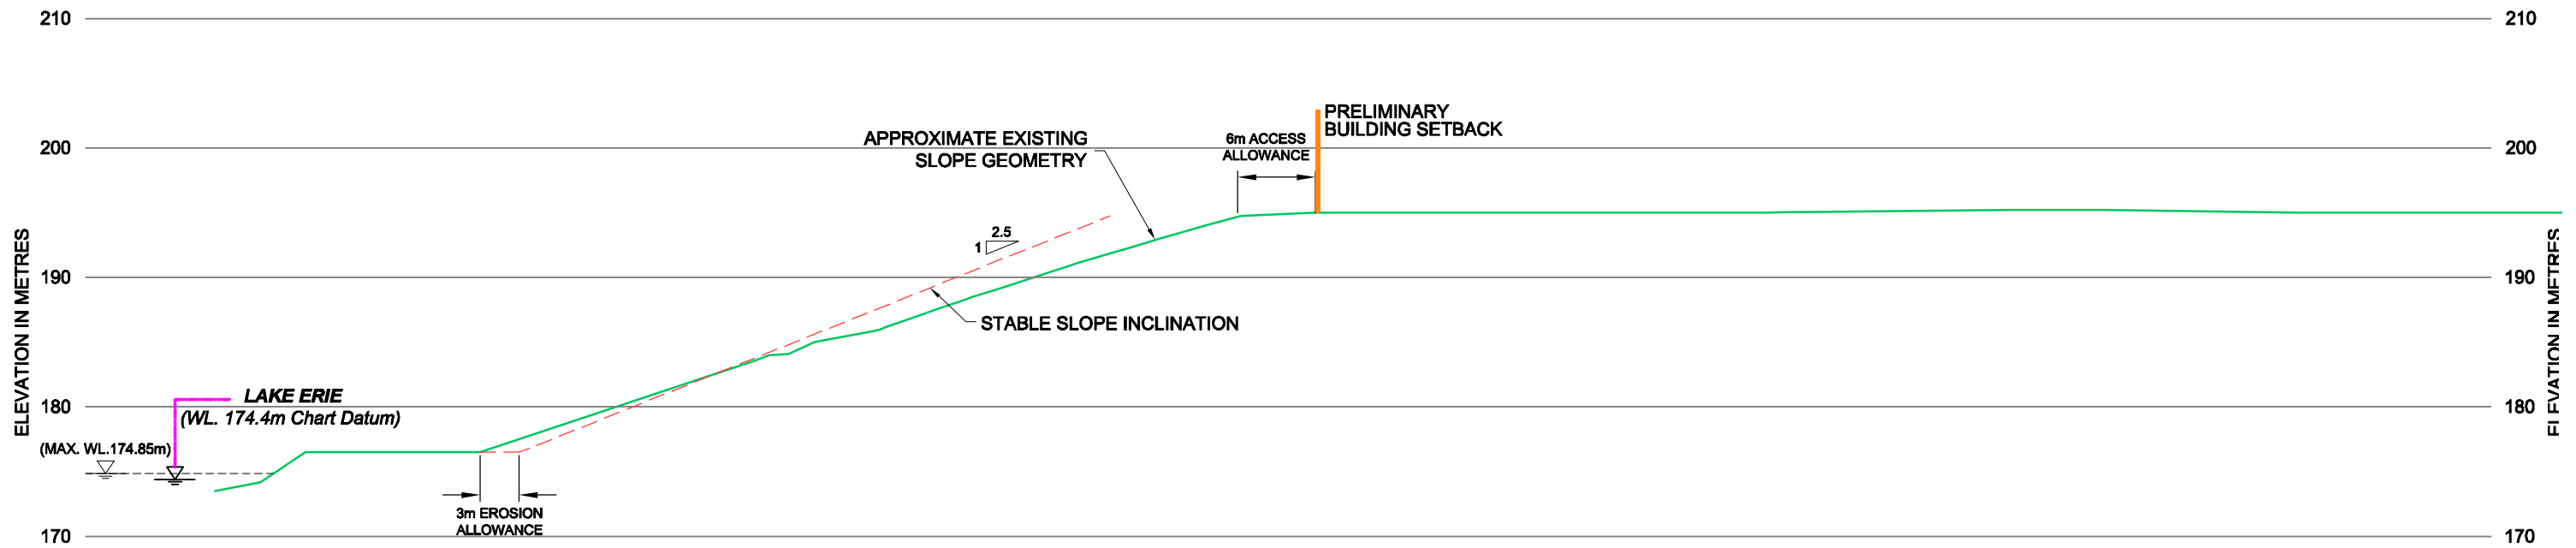
CROSS SECTION A-A

Based on information available on the Canadian Hydrographic Service web site, the Lake Erie water level is generally at about elevation 174.4 metres (International Great Lakes Datum (IGLD)) or about 0.9 metres above the chart datum elevation of 173.5 metres. The maximum lake level is expected to be 1.35 metres above chart datum or at elevation 174.85 metres. The Lake Erie water level was measured at elevation 174.30 metres (referenced to geodetic datum) at the marina on August 21, 2011. These levels are shown on the relevant cross section on Figure 3 (Section A-A).

The recommended inclinations and setbacks are shown on the cross sections on Figures 3 to 5 and the preliminary building setbacks are shown on Figure 2.

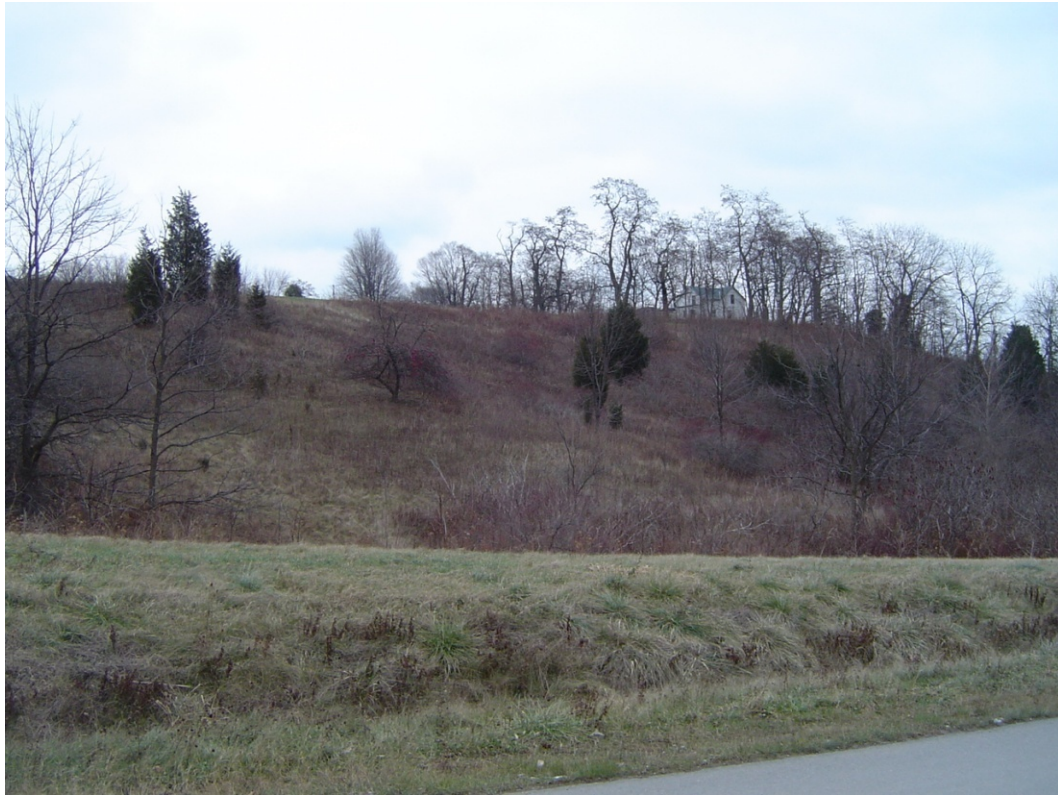
Photo 1: General view of slope on east part of Lot 6, Concession 14. Looking east from Havens Lake Road (access road to the marina).

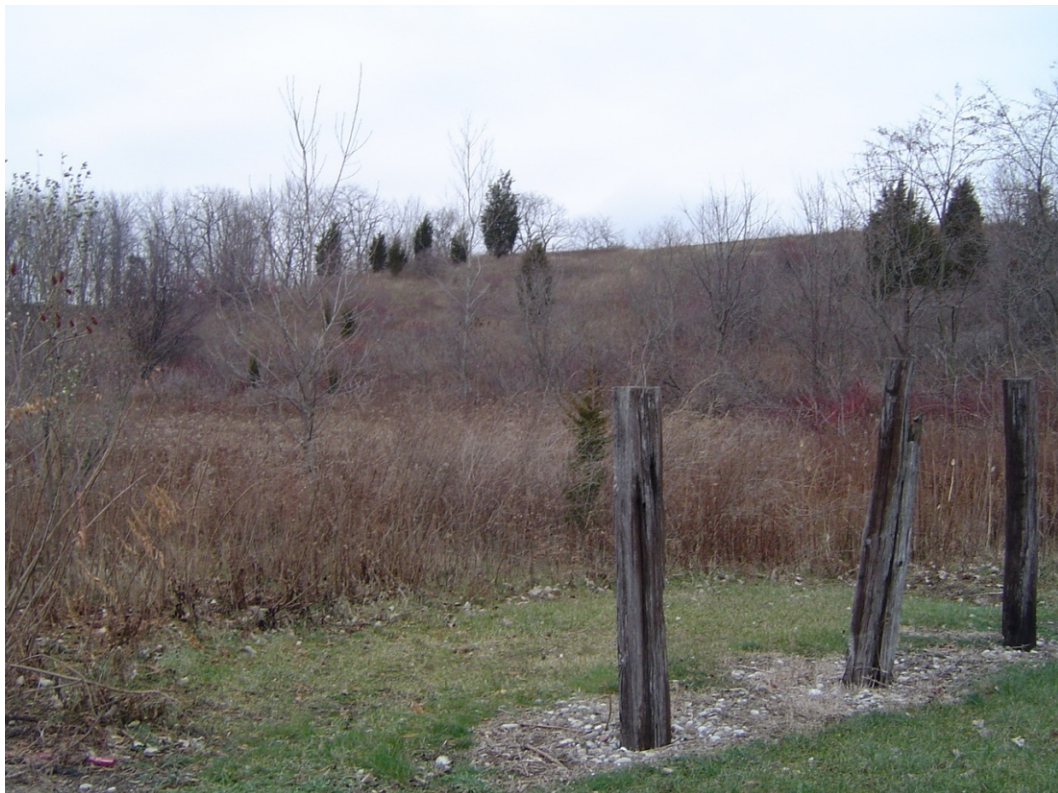
Photo 2: Slope on east part of Lot 6, looking north from marina parking lot.

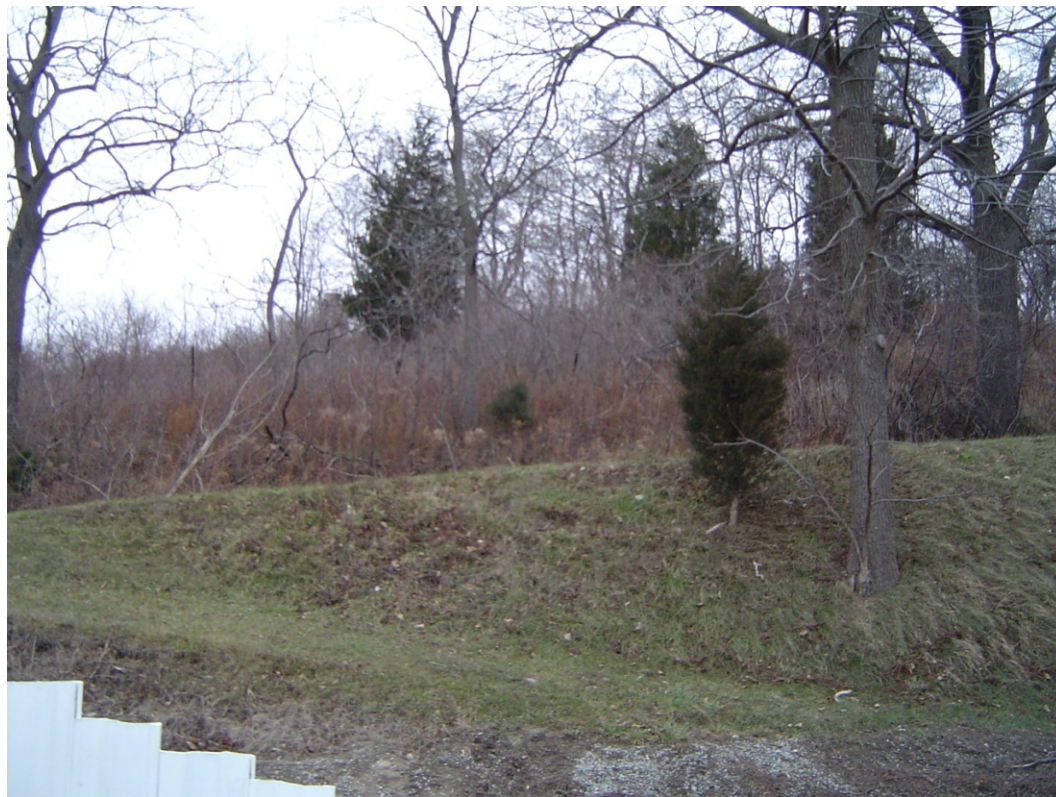
Photo 3: Slope near east end of marina parking lot.

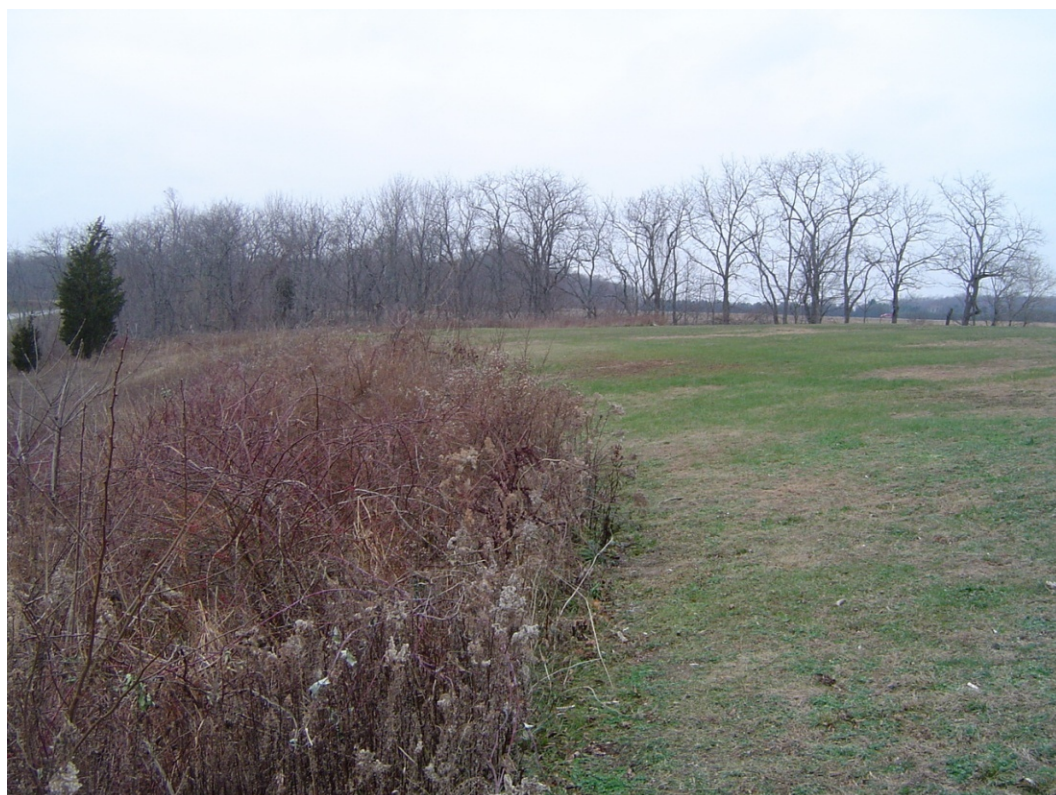
Photo 4: Table lands at top of slope on east portion of Lot 6, looking northwest.

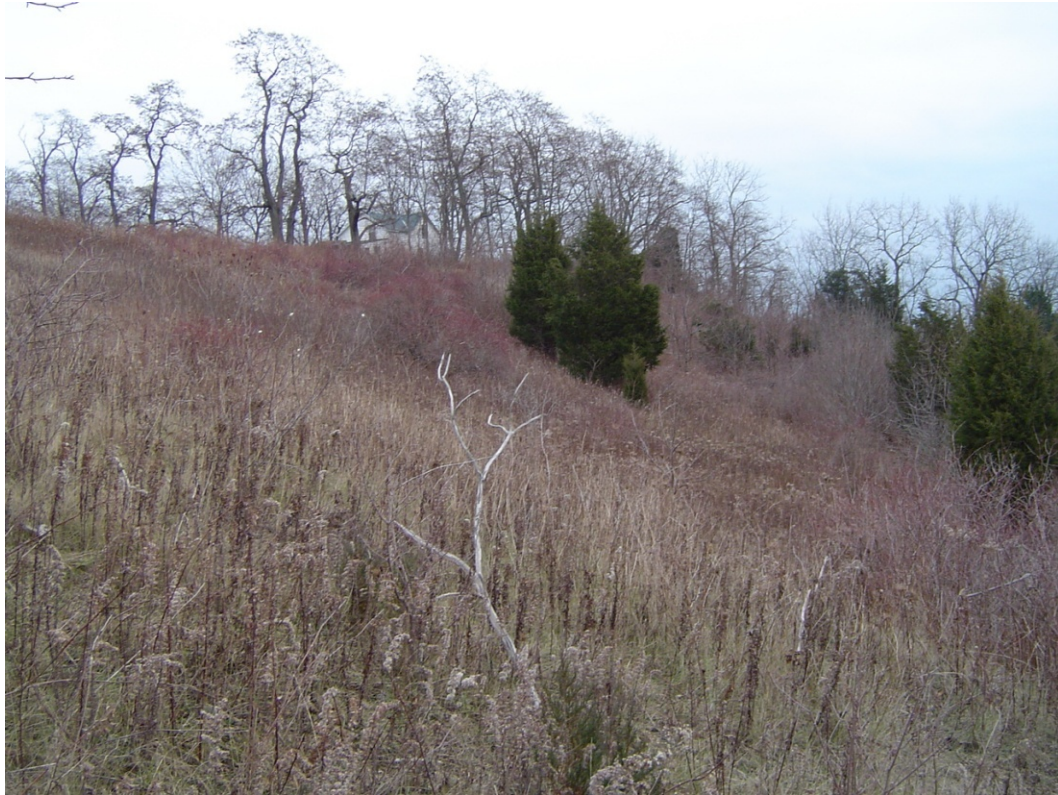
Photo 5: Upper portion of slope on east part of Lot 6, looking southeast towards location of cross section B-B.

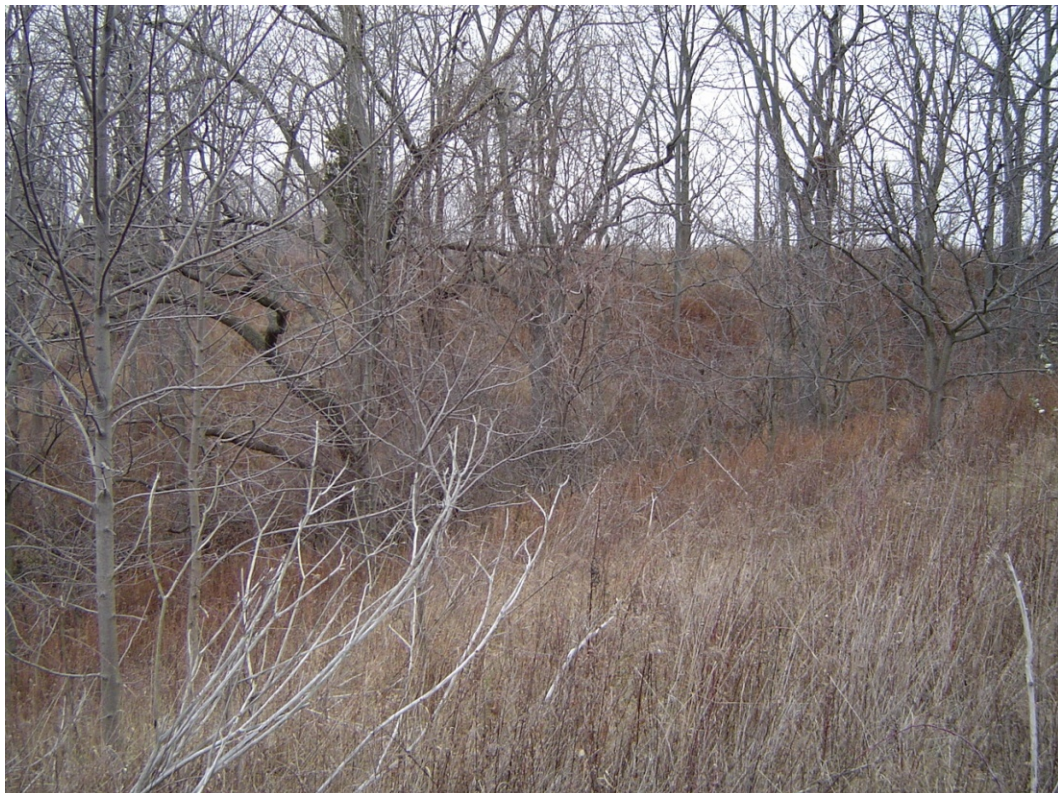
Photo 6: Gully on east part of Lot 6, looking northwest.

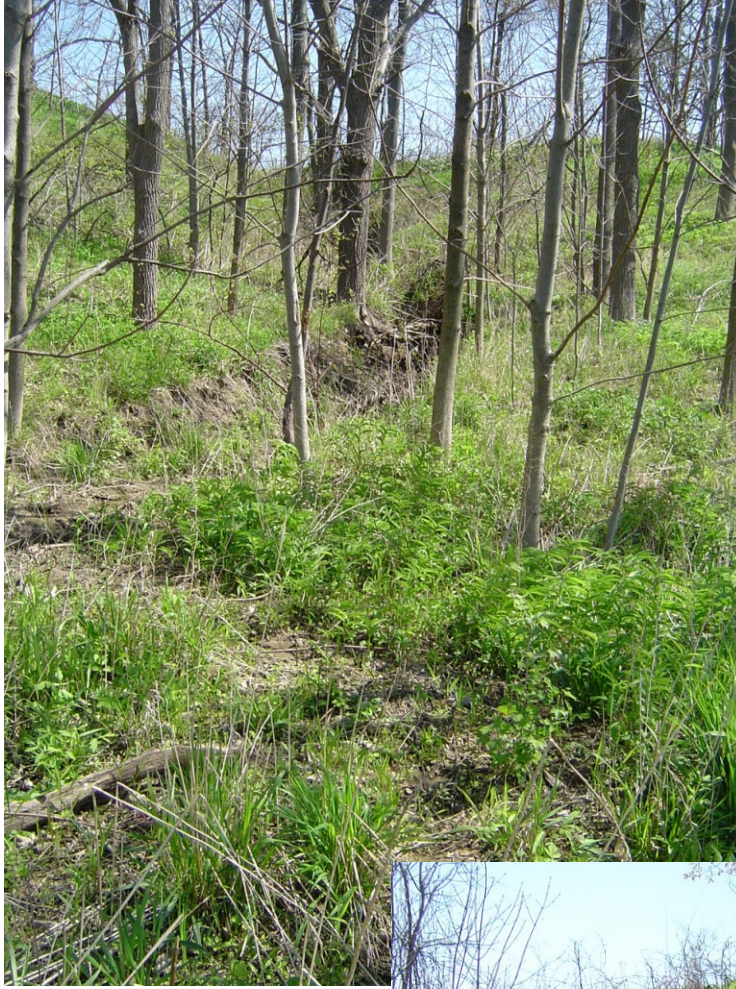
Photo 7: Existing gully east of Havens Lake Road and south of Gray Line, looking north.

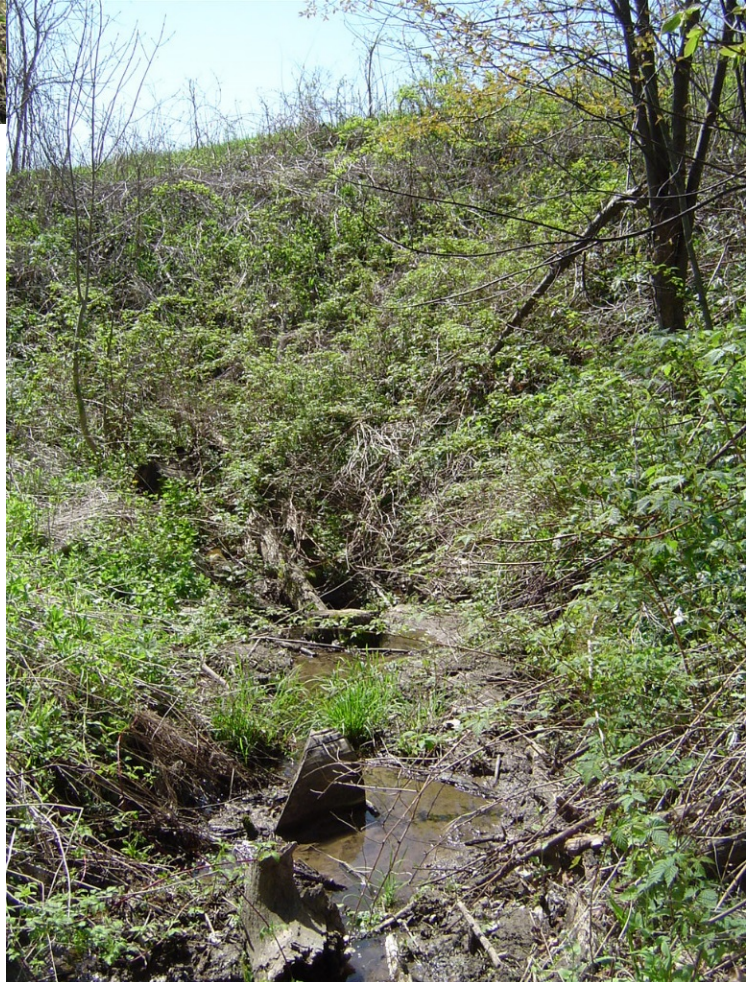
Photo 8: Culvert pipe at filled portion of gully east of Havens Lake Road and south of Gray Line, looking south.

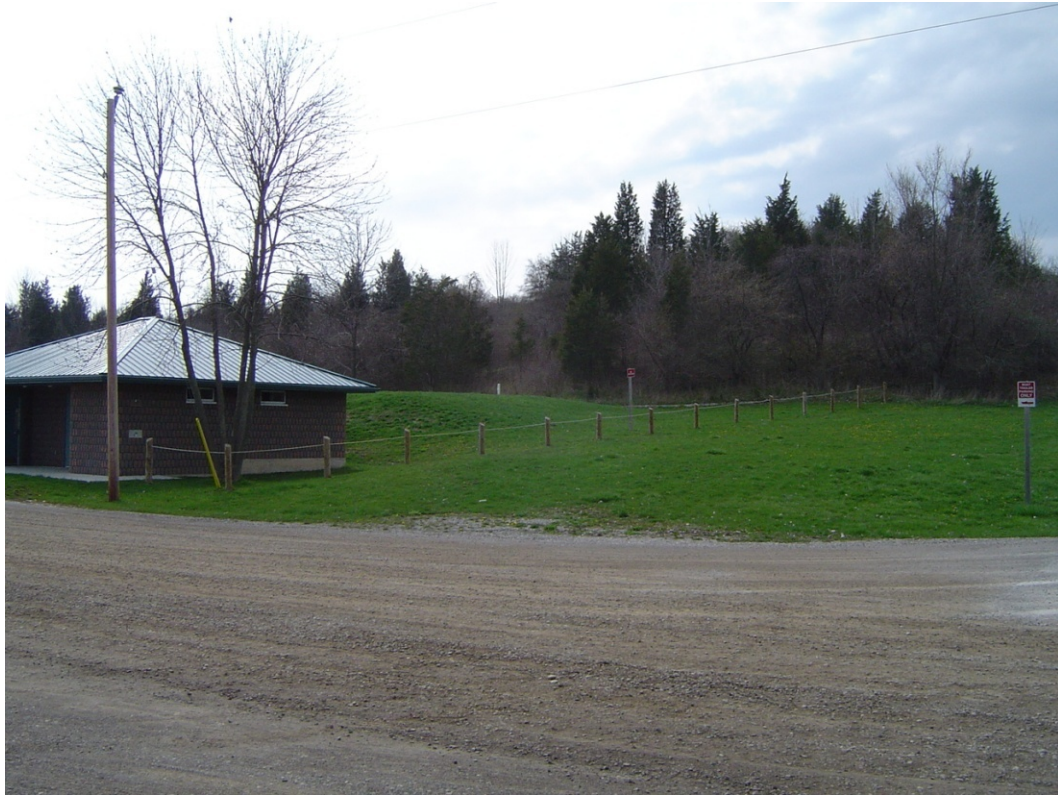
Photo 9: Public washrooms on north side of marina. Note treed slope in background.

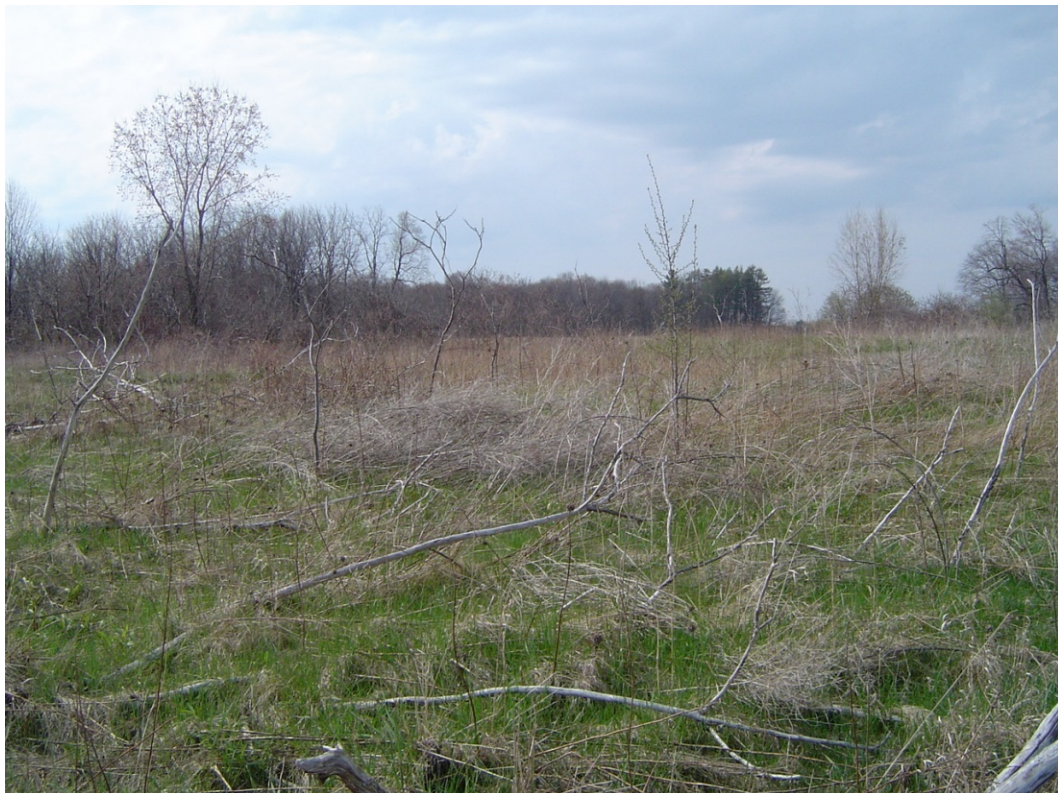
Photo 10: General view of table lands west of Havens Lake Road and north of public washrooms.

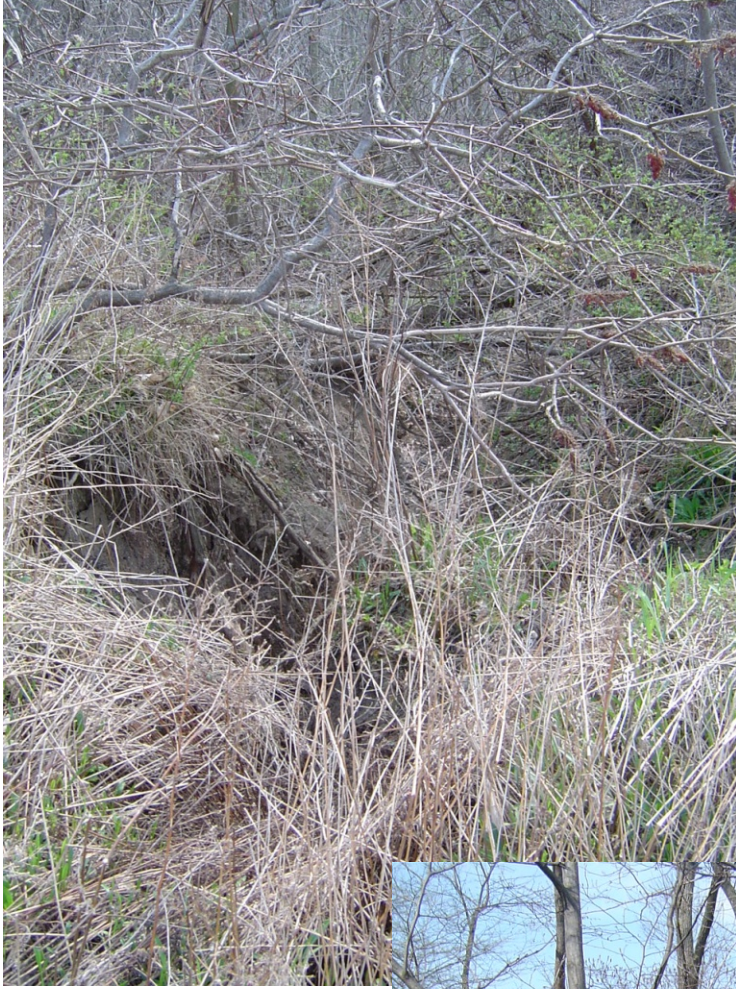
Photo 11: Shallow gully forming on slope of table lands west of Havens Lake Road (typical).

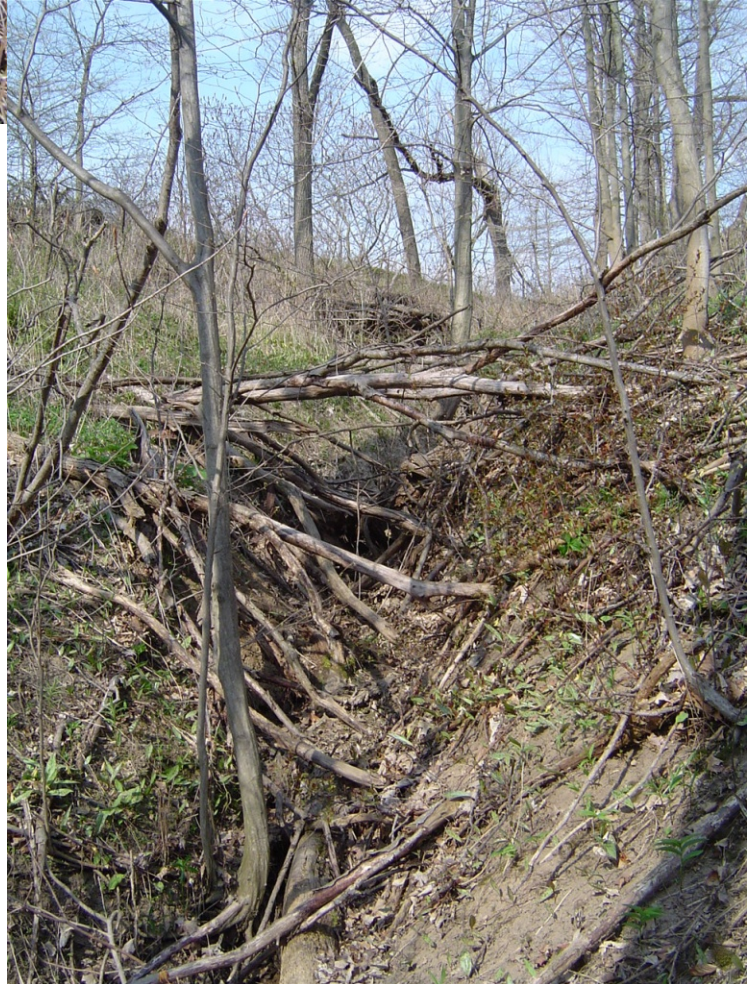
Photo 12: Looking up the slope at another gully towards table lands west of Havens Lake Road.

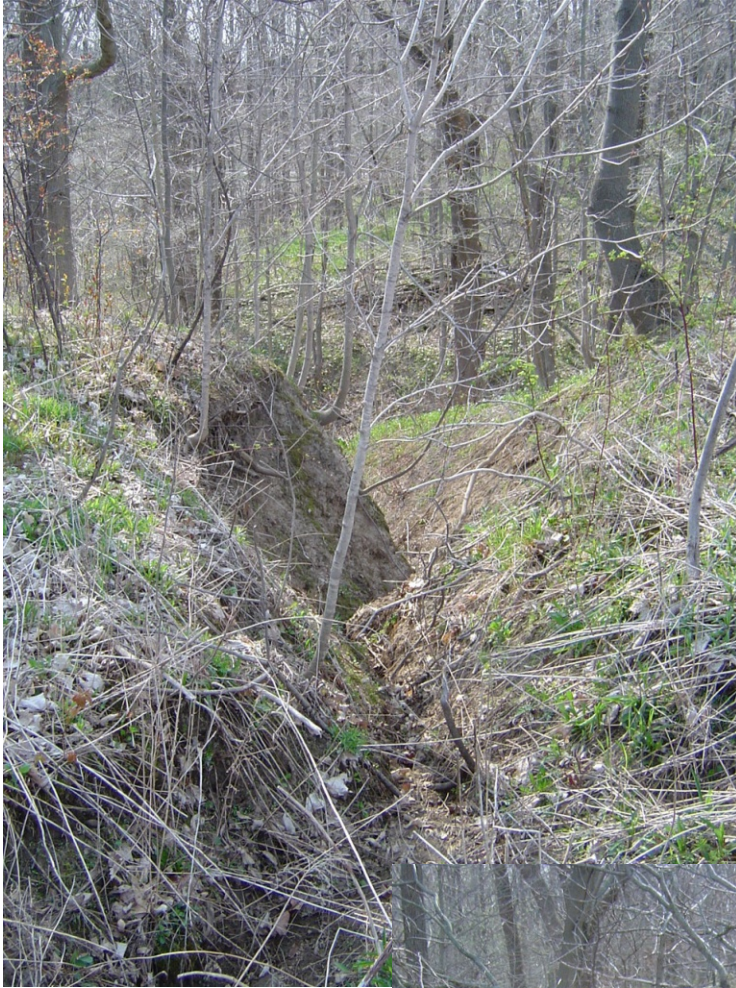
Photo 13: Gully in northern portion of table lands west of Havens Lake Road.

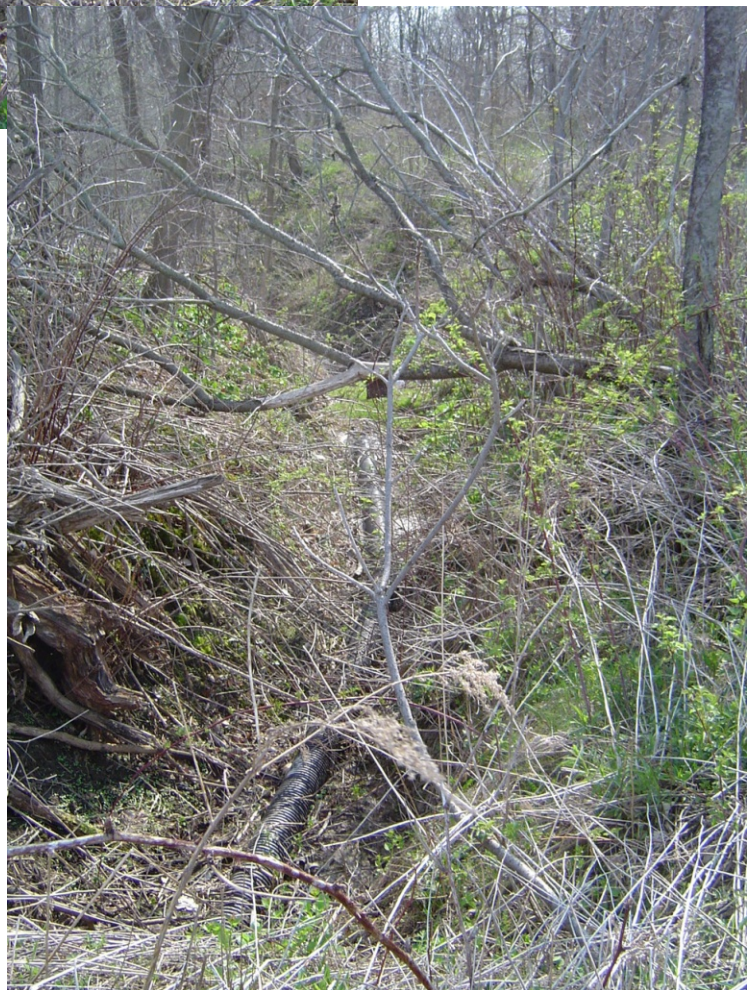
Photo 14: Drain pipe at top of gully forming south of Gray Line.

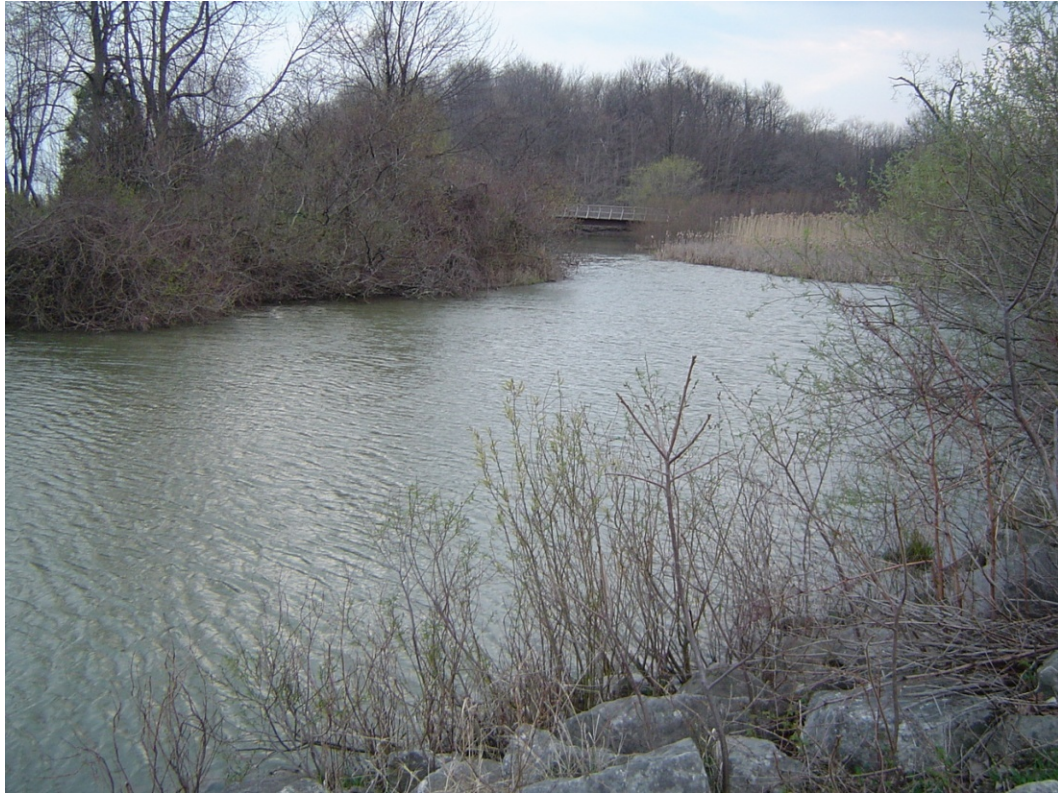
Photo 15: South end of Sixteen Mile Creek looking northwest towards foot bridge from Lake Erie.
