Facility Description

Facility Name: West Elgin Distribution System Regional Manager: Dale LeBritton (519) 476-5898 Sr. Operations Manager: Sam Smith (226) 377-1540

Facility Name: West Elgin Distribution System

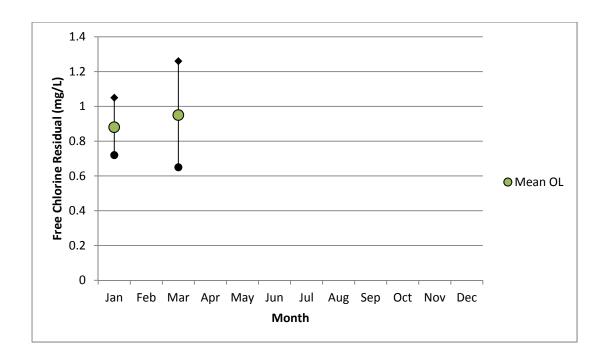
The Rodney Tower continuously monitors the free chlorine residual of the water. The results fluctuate based on fill cycles. The chart below shows the minimum, maximum and average daily free chlorine residuals. During the winter months the results are usually very good, however, once there is warmer weather the chlorine residuals dissipate. It is required to maintain 0.2mg/L of free chlorine in the distribution system. Therefore, the residual leaving the tower must be above this 0.2mg/L. An adverse reportable event occurs when the chlorine residuals drops below 0.05mg/L. During the 1st quarter the tower was upgraded to be able to rechlorinate.
