West Elgin Distribution System Operations Report Second Quarter 2018

Submitted by:
Ontario Clean Water Agency
Date: July 18, 2018

Facility Name: West Elgin Distribution System

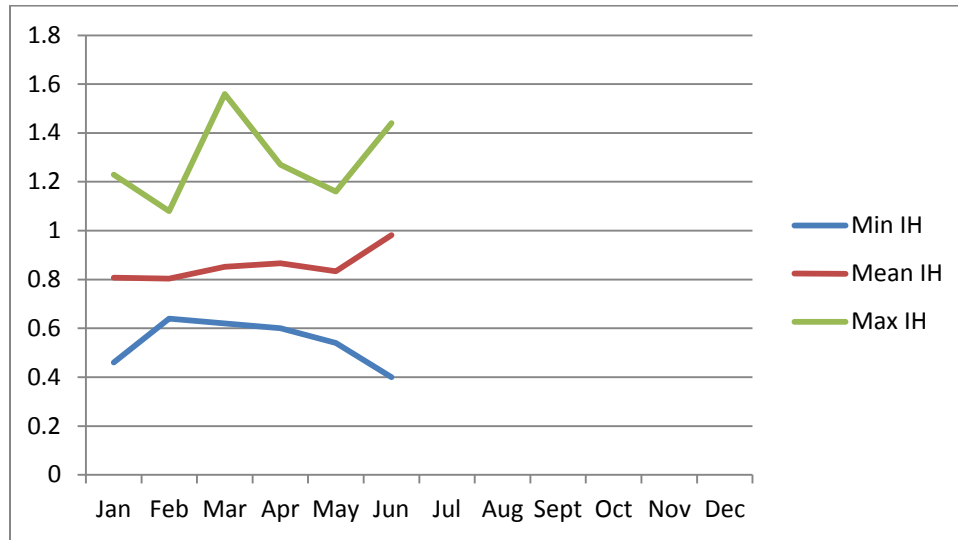
The Rodney Tower continuously monitors the free chlorine residual of the water. The results fluctuate based on fill cycles. The chart below shows the minimum, maximum and average daily free chlorine residuals. During the winter months the results are usually very good, however, once there is warmer weather the chlorine residuals dissipate. In Spring of 2018 the Rodney tower installed a re-chlorination facility. Chlorine residuals are taken throughout the distribution system in accordance to O. Reg. 170/03 requirements. The graph below provides the minimum, maximum and average chlorine residuals throughout the distribution system in 2018.
