Rodney Wastewater Treatment Plant
Operations Report
Third Quarter 2020

Submitted by:
Ontario Clean Water Agency
Date: November 5, 2020

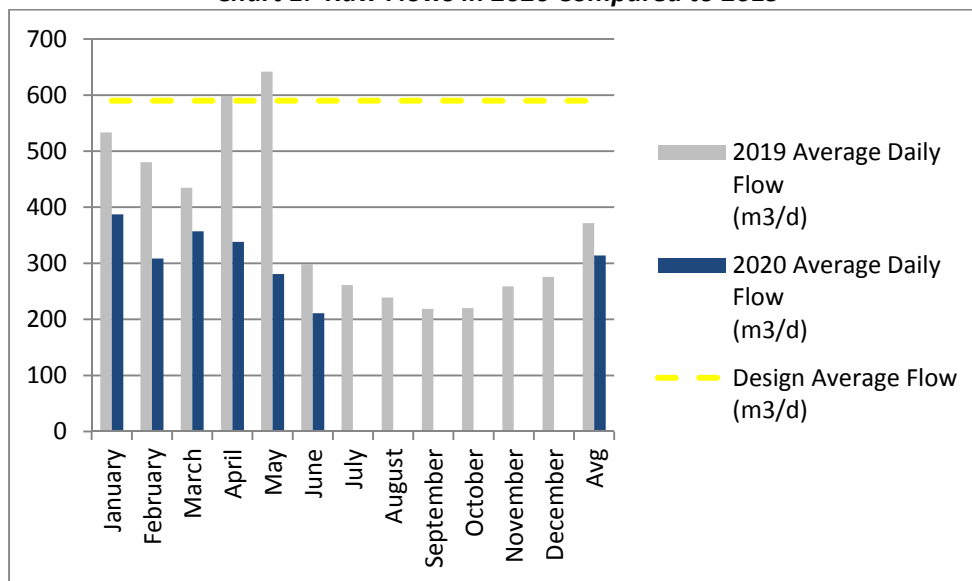
Chart 1. Raw Flows in 2020 Compared to 2019

The average daily flow for the wastewater treatment plant in 2020 is 319.87m³/d. The average daily flow in 2019 was 371.7 m³/d, therefore the flow for 2020 is down by 14% when compared to 2019. The plant is currently at 54% of its rated capacity of 590m³/d.

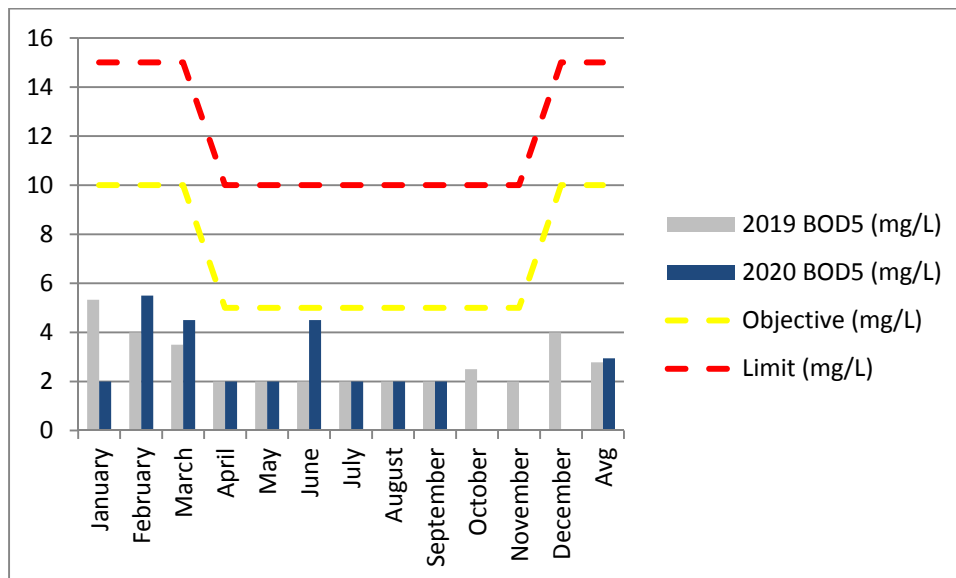
Chart 2. Average Monthly Effluent BOD5 results for 2020 compared to 2019.

The average effluent BOD5 for 2020 is 2.9mg/L, meeting both effluent objectives and limits identified in the ECA. The annual average result for BOD5 in 2019 was 2.78mg/L, therefore the results for 2020 so far are up by 6% when compared to 2019 (refer to Chart 2).

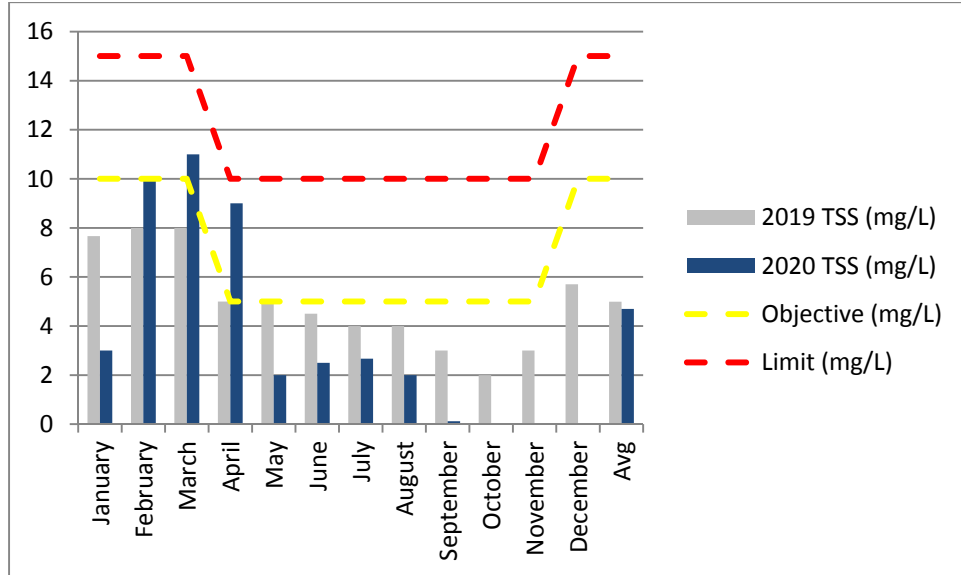
Chart 3. Average Monthly Effluent Total Suspended Solids Results for 2020 Compared to 2019

The average effluent TSS for 2020 is 4.7 mg/L, meeting the effluent limit identified in the ECA but exceeding the objective in March and April. The annual average result for TSS in 2019 was 5mg/L, therefore the results for 2020 are down by 6% when compared to 2019 (refer to Chart 3).

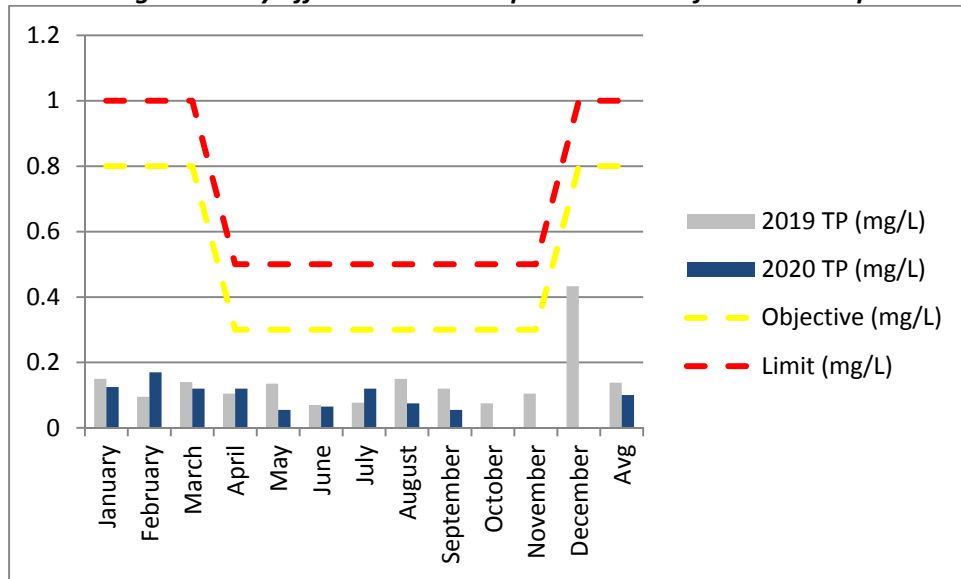
Chart 4. Average Monthly Effluent Total Phosphorus Results for 2020 Compared to 2019

The average effluent TP for 2020 is 0.10 mg/L, meeting both effluent objectives and limits identified in the ECA. The annual average result for TP in 2019 was 0.14mg/L, therefore the results for 2020 are down 27% when compared to 2019 (refer to Chart 4).

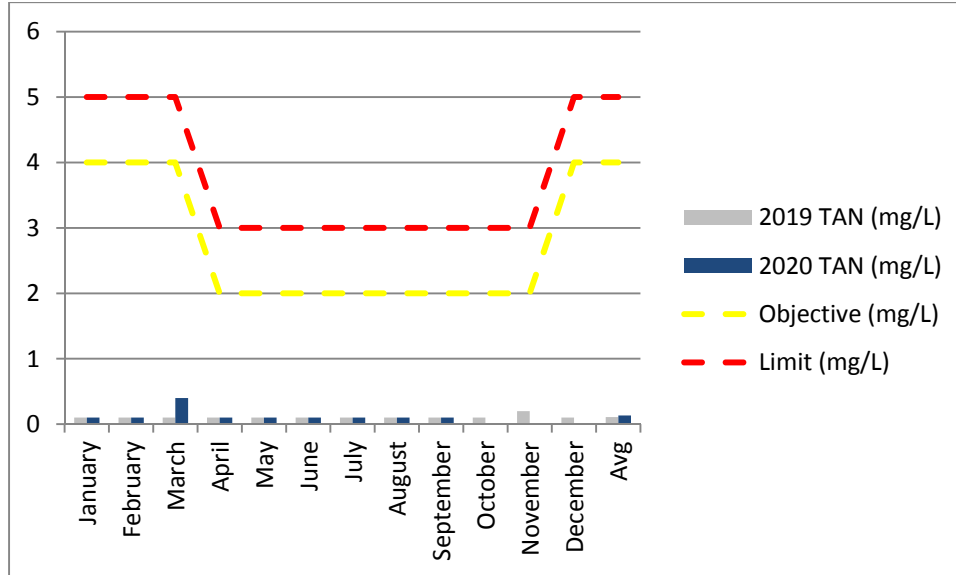
Chart 5. Average monthly Effluent Total Ammonia Nitrogen Results for 2020 Compared to 2019

The average effluent TAN for 2020 is 0.13 mg/L, meeting both effluent objectives and limits identified in the ECA. The annual average result for TAN in 2019 was 0.11mg/L, therefore the results for 2020 so far are up by 23% when compared to 2019 (refer to Chart 5).

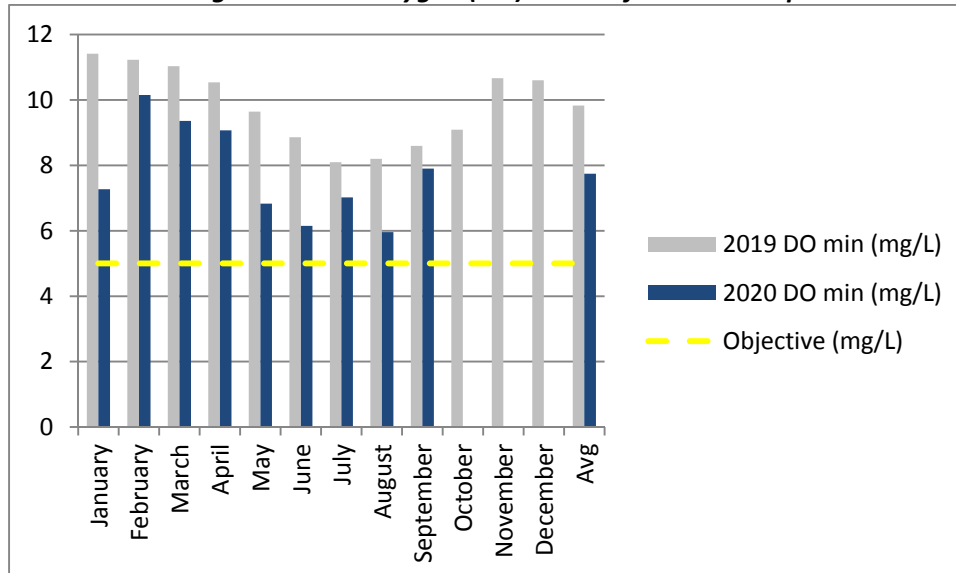
Chart 6. Average Dissolved Oxygen (DO) Results for 2020 Compared to 2019

Dissolved oxygen (DO) of the effluent is tested on site at the plant; the ECA identifies a minimum level required as an objective. This objective is 5mg/L. The chart below (Chart 6) shows the minimum DO concentrations, there have been no objective exceedances.

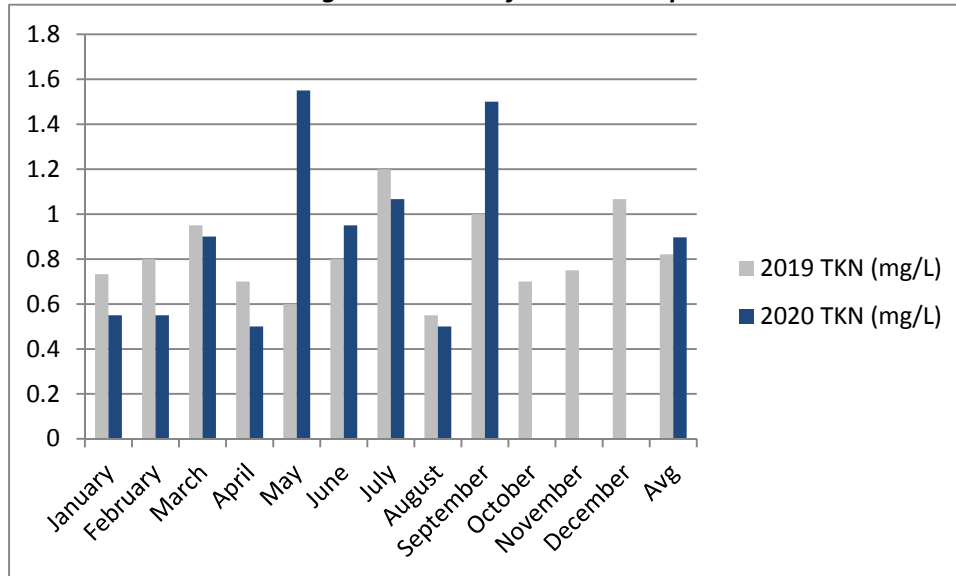
Chart 7. Average TKN Results for 2020 Compared to 2019

Total Kjeldahl Nitrogen (TKN) is sampled biweekly in accordance with ECA requirements; there are no objective or limits imposed on this parameter. The average effluent TKN for 2020 is 0.90 mg/L. The annual average result for TKN in 2019 was 0.82mg/L; therefore the results for 2020 so far are up by 9% when compared to 2019 (refer to Chart 7).

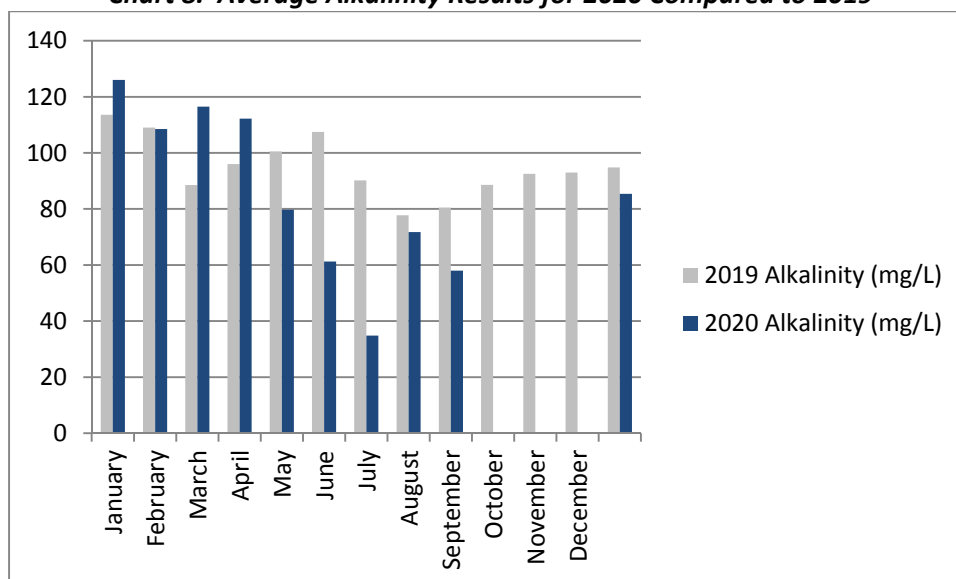
Chart 8. Average Alkalinity Results for 2020 Compared to 2019

Alkalinity is sampled at least biweekly in accordance with ECA requirements; there are no objective or limits imposed on this parameter. It is recommended that at least 50mg/L is present in the effluent. The average effluent alkalinity for 2020 is 84mg/L. The annual average result for alkalinity in 2019 was 94.8mg/L, therefore the results for 2020 so far are down by 10% when compared to 2019 (refer to Chart 8).

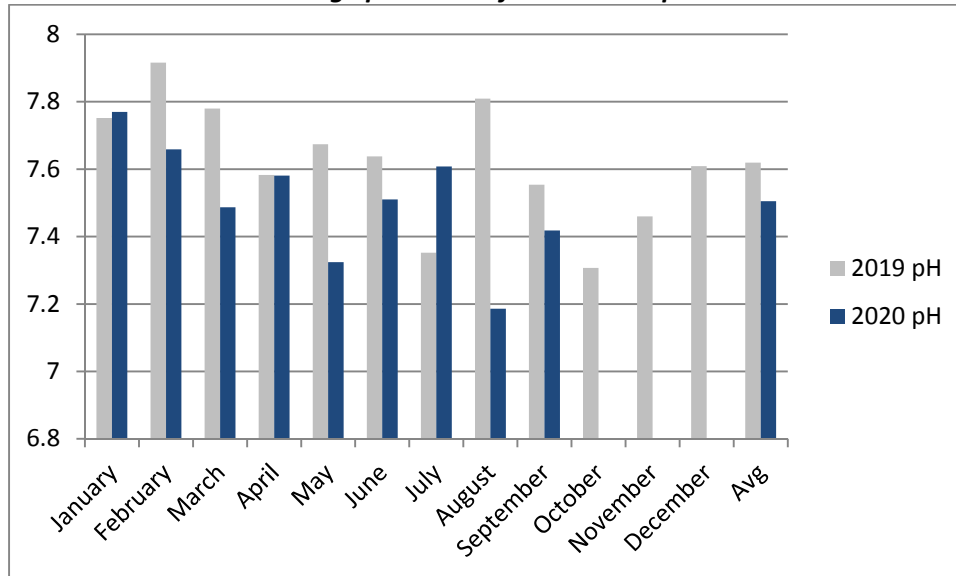
Chart 9. Average pH Results for 2020 Compared to 2019

pH is sampled at least biweekly in accordance with ECA requirements; there are no objective or limits imposed on this parameter. It is recommended that the pH is in the range of 6.5-8.5. The average effluent pH for 2020 so far is 7.50. The annual average result for pH in 2019 was 7.62; therefore the results for 2020 is down by 1.5% when compared to 2019 (refer to Chart 10).

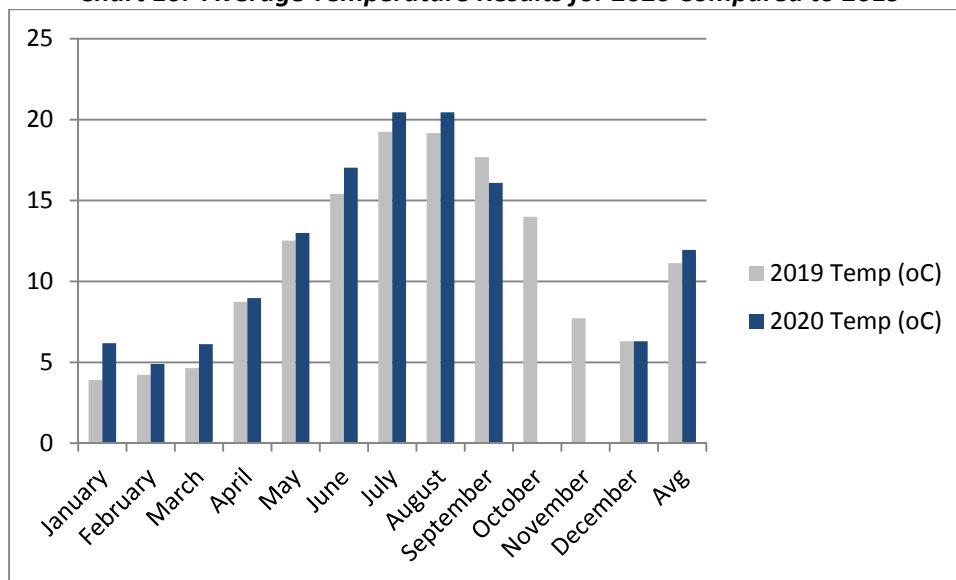
Chart 10. Average Temperature Results for 2020 Compared to 2019

Temperature is measured at least biweekly in accordance with ECA requirements; there are no objective or limits imposed on this parameter. The temperature of the effluent fluctuates based on outdoor temperatures. The average effluent temperature for 2020 is 12°C. The annual average temperature in 2019 was 11.1°C, therefore the results for 2020 are up 7.4% when compared to 2019 (refer to Chart 11).
